DEPARTMENT OF TRANSPORTATION

Office of Structural Materials

Contract #: 04-0120F4Cty: SF/ALA Rte: 80 PM: 13.2/13.9File #: 1.28**WELDING INSPECTION REPORT****Resident Engineer:** Casey, William**Address:** 333 Burma Road**City:** Oakland, CA 94607**Report No:** WIR-028596**Date Inspected:** 15-Oct-2012**Project Name:** SAS Superstructure**OSM Arrival Time:** 700**Prime Contractor:** American Bridge/Fluor Enterprises, a JV**OSM Departure Time:** 1730**Contractor:** American Bridge/Fluor Enterprises, a JV**Location:** Job Site

WELDING INSPECTION REPORT

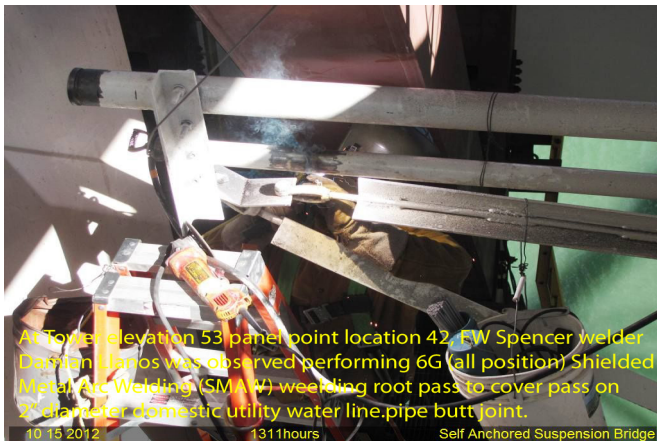
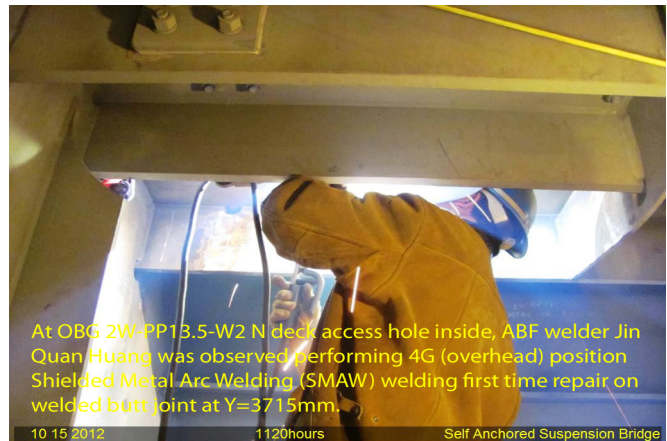
At Tower location elevation 50.3 meter, this QA randomly observed FW Spencer qualified welder Damian Llanos continuing to perform Complete Joint Penetration (CJP) 6G (all position) Shielded Metal Arc Welding (SMAW) welding fill pass to cover pass on the 2" domestic utility water line field splice butt joint. The welder was noted welding the root pass with 3/32" E6010 followed by fill and cover pass with 3/32" diameter E7018H4R electrode implementing Caltrans approved procedure FW Spencer WPS 1-12-1. The welder was noted preheating and removing the moisture of the joint using a portable propane gas torch prior welding. During welding, ABF QC Steve Jensen was noted monitoring the parameters of the welder. At the end of the shift, only one 2" diameter pipe splice butt joint #8 located at panel point PP42 Tower elevation 53 meter was completed.
